CRASH INJURY BULLETIN

**MODIFICATIONS TO THE PASSENGER SEAT-BELT
TIEDOWN ATTACHMENTS IN THE**

U.S. ARMY HU-1 SERIES BELL IROQUOIS HELICOPTER

TCREC Technical Report 62-45

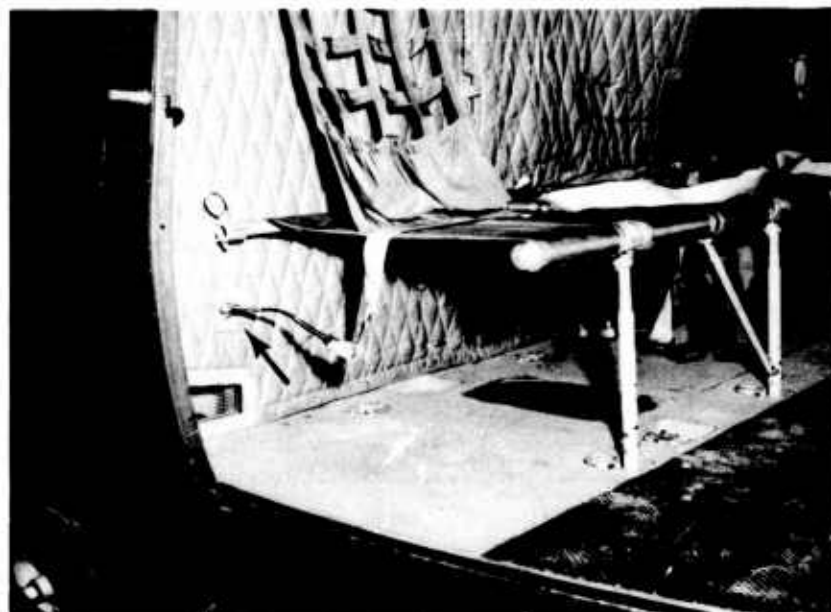
Figure 2. Typical Seat-Belt Tiedown Installation in the HU-1 Helicopter.

A review of several HU-1 helicopter accidents* reveals that failure of the passenger seat-belt tiedown occurs at the casting where the cable clevis is attached.

Figure 2 illustrates the tiedown installation as presently installed in HU-1 helicopters.
